THAMES RIVER BASIN  
BOLTON, CONNECTICUT

LOWER BOLTON LAKE DAM  
CT 00509

PHASE I INSPECTION REPORT  
NATIONAL DAM INSPECTION PROGRAM

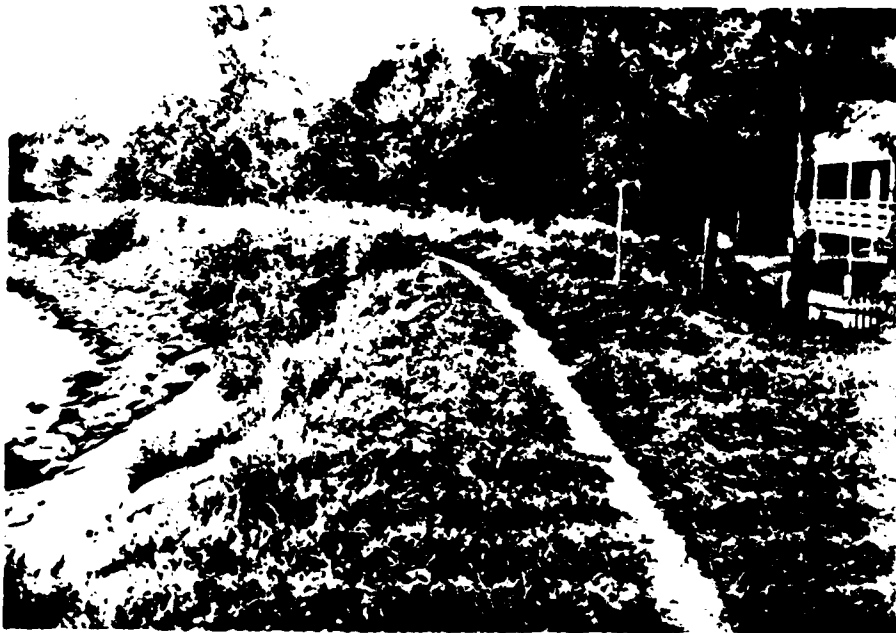
The visual inspection of the Lower Bolton Lake Dam took place on 25 September 1978. The dam is in fair condition. Slope protection on the upstream face has been displaced and the downstream face is covered with brush. The spillway crest structure is considerably cracked and the individual concrete slabs have unequal vertical offsets and displacements. The downstream channel is heavily overgrown with trees and brush.

1. Dike showing brush on slopes and houses downstream

The owner should implement the following maintenance measures: remove brush and trees from dam embankment; reinstate riprap on upstream slope; monitor wet areas at toe of downstream slope; monitor cracks in spillway structure; develop a formal flood warning system and emergency operational procedure.

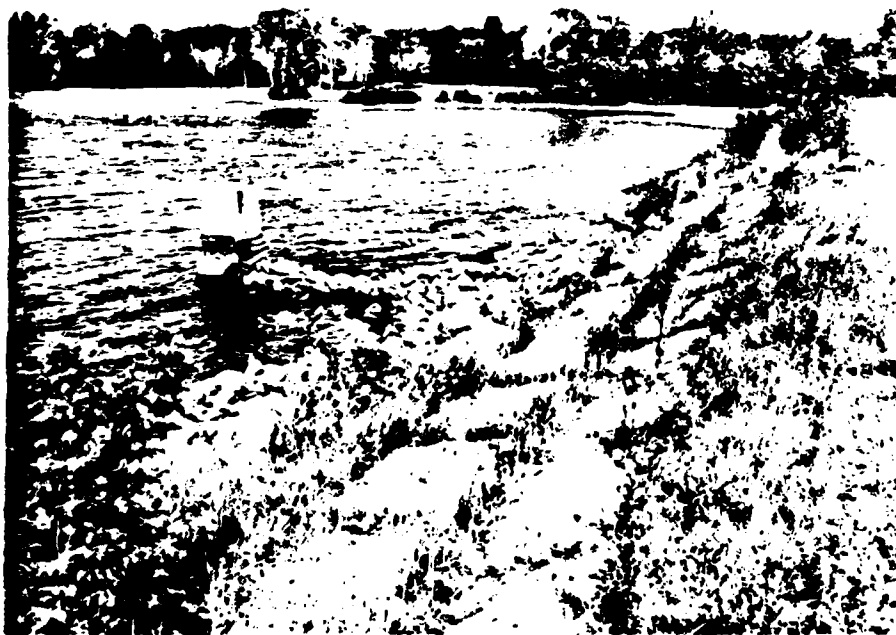
The dam consists of an earth dike with a spillway on the left abutment. The dike shows no evidence of horizontal or vertical movement. No evidence of seepage was observed on the downstream slope of the dike embankment, including the area between the outlet structure and the spillway, where the 1938/41 breaches occurred. The toe on the right abutment is damp but there is no indication of any significant seepage. The downstream slope is generally overgrown with brush of the order of 3 ft. to 4 ft. high (Appendix C, Photo No. 1). Between the spillway and the angle point in the dike, the lower part of the upstream slope is protected with cobble riprap mostly under 2 ft. dia., while the upper part is covered with concrete slabs (Appendix C, Photo No. 2). Between the angle point and the right abutment all the slope protection consists of concrete slabs. Some of these have been sliding down the slope (Appendix C, Photo No. 3). About 75 ft. to 80 ft. right of the outlet structure there is a noticeable gully in the upstream slope between 1 ft. and 2 ft. deep and 35 ft. to 40 ft. long. There is a second, smaller gully about 20 ft. long and 1 ft. deep in the concrete slab slope protection slightly left of the intake structure. Some riprap is missing in this vicinity.

2. Upstream face of dike and 15"  $\emptyset$  outlet valve structure
